Goal:  
enable USB OTG/  
USB Host

## PinePhone 1.2 VCONN Hardware Fix

This page details a hardware fix for an issue that was found on early PinePhone hardware revisions (see [PinePhone#Hardware revisions](#) for an overview of the different revisions) and has been fixed since the 1.2a hardware revision.

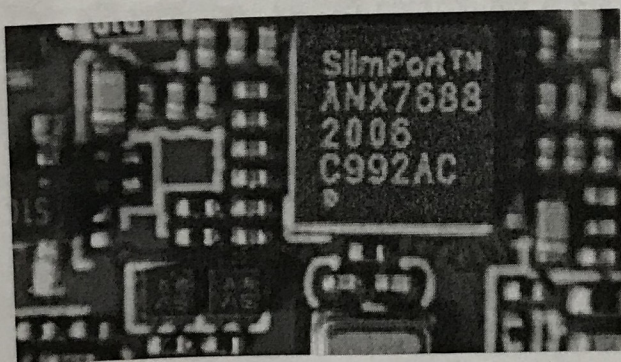
Close-up picture of the two identical switches the issue originates from, with the ANX USB controller in the frame

The issue arises due to the switches that were chosen up to v1.2a (the a revision excluded) of the PCB assembly: the infamous AW3512, labelled U1305 and U1309 on the schematic. Instead of leaving the output pin "dangling" with a high impedance when disabled, the switch pull the output down. This feature is intended for discharging a capacitor, hence its "Quick output discharge" name. This is an excerpt from the datasheet:

This issue prevents cable plug/orientation detection and USB-PD communication. ANX always sees cable as plugged even if none is plugged. There's no SW workaround for automatic detection of cable plug or power role.

Hardware workaround is desoldering U1305 and U1309 switches (BGA like packages). This will void the VCONN control, but it will release the CC pins for their proper connection detection and negotiation roles.

HW fix is to replace AW3512 with a variant of the chip that preserves the EN signal polarity and that doesn't have the "quick discharge function" that ties the output to the GND via a 75 Ohm resistor when the switch is OFF. mozzwald used NCP334FCT2G as a replacement. PCBA revision 1.2a onwards incorporate that fix.

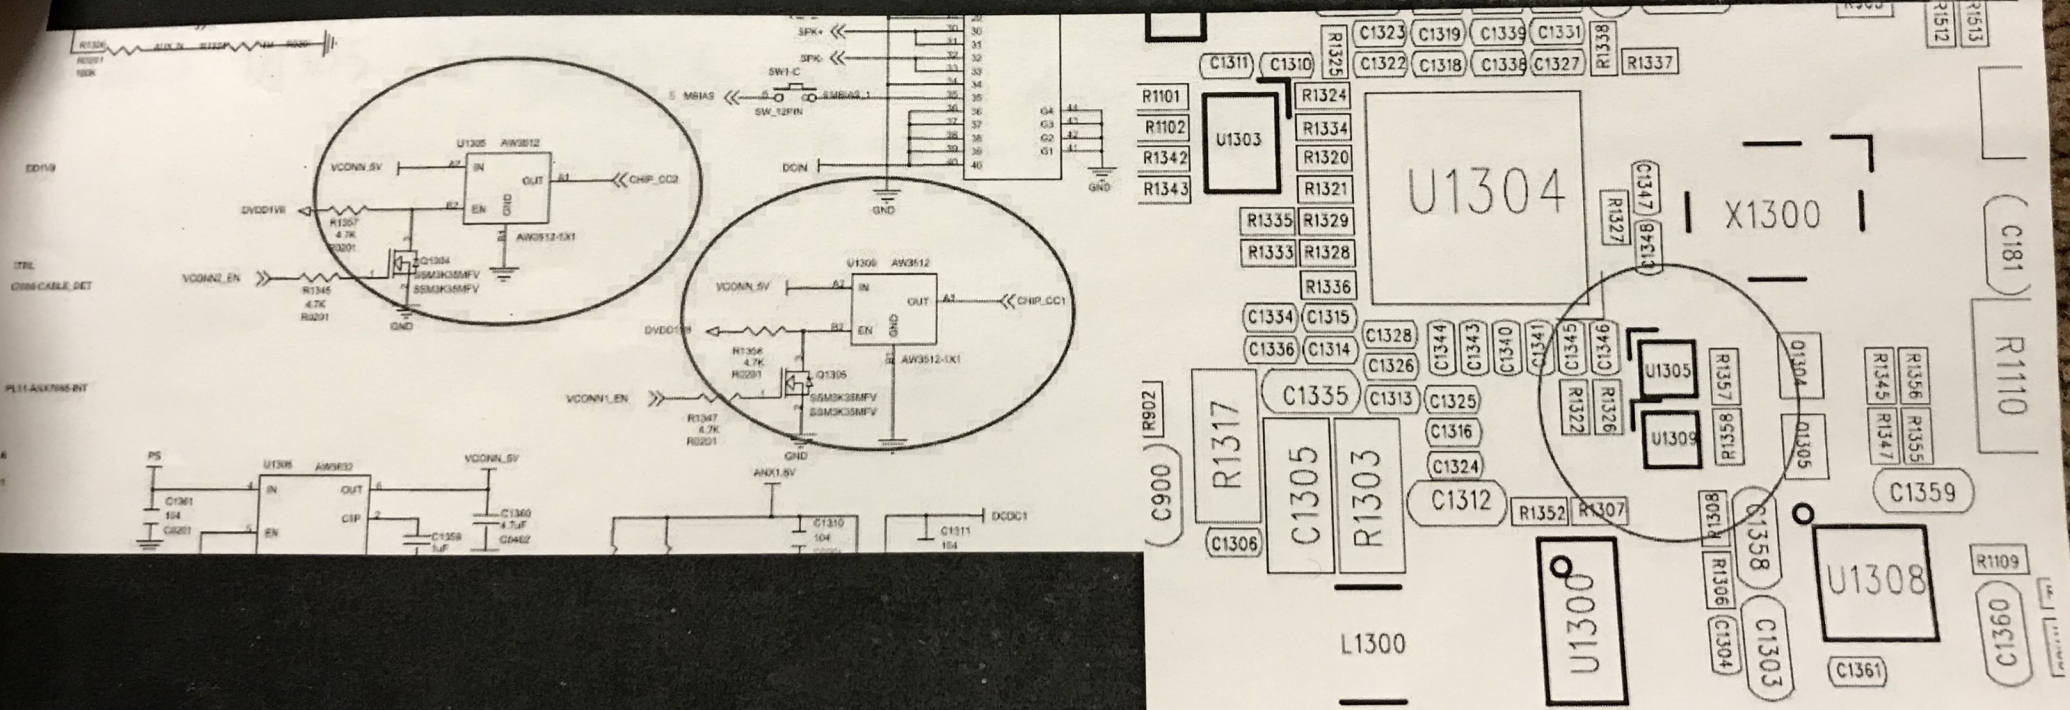
To fix USB-C CC pins, we need to desolder VCONN switches that are tying the CC pins to the ground when they're off, p from functioning correctly.

- careful of other components
- carefully remove + heat U1305, U1309
- careful not to short things around/below

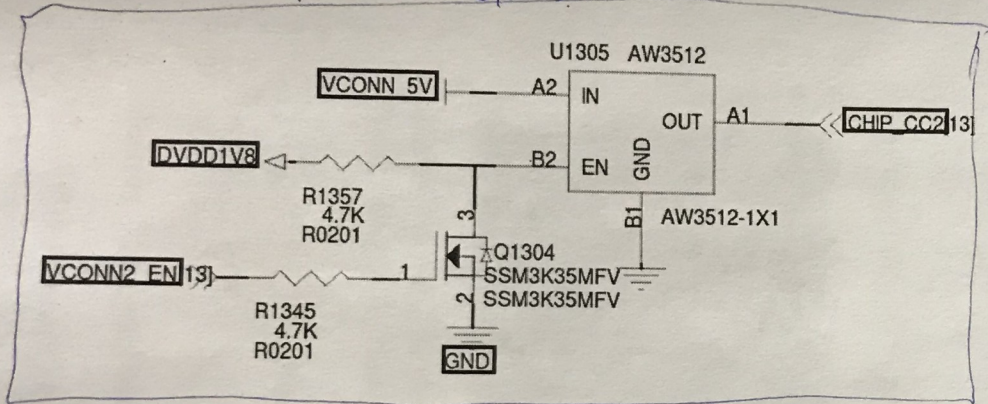
Desolder U1305 and U1309 to release CC pins  
which are always grounded

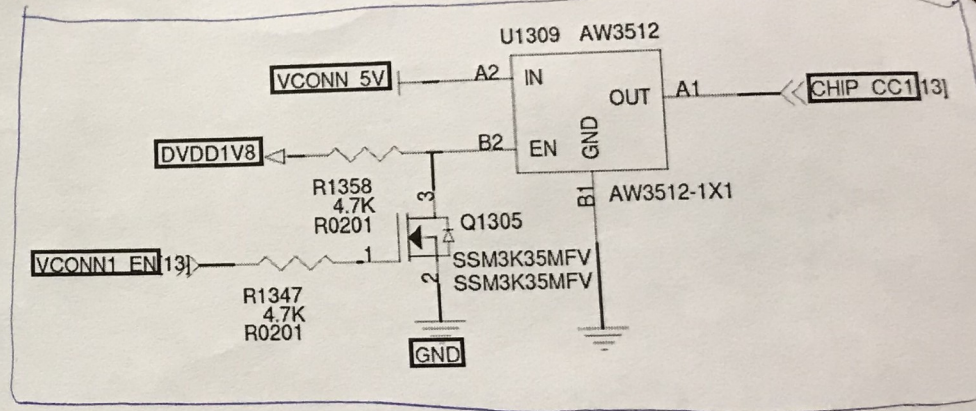
U1309

AW3512 switches
